Zibby Garnett Travelling Fellowship

Report by Scott MacAskill

Traditional masonry works at Nidaros Cathedral,
Trondheim, Norway

21 August – 2 September 2016

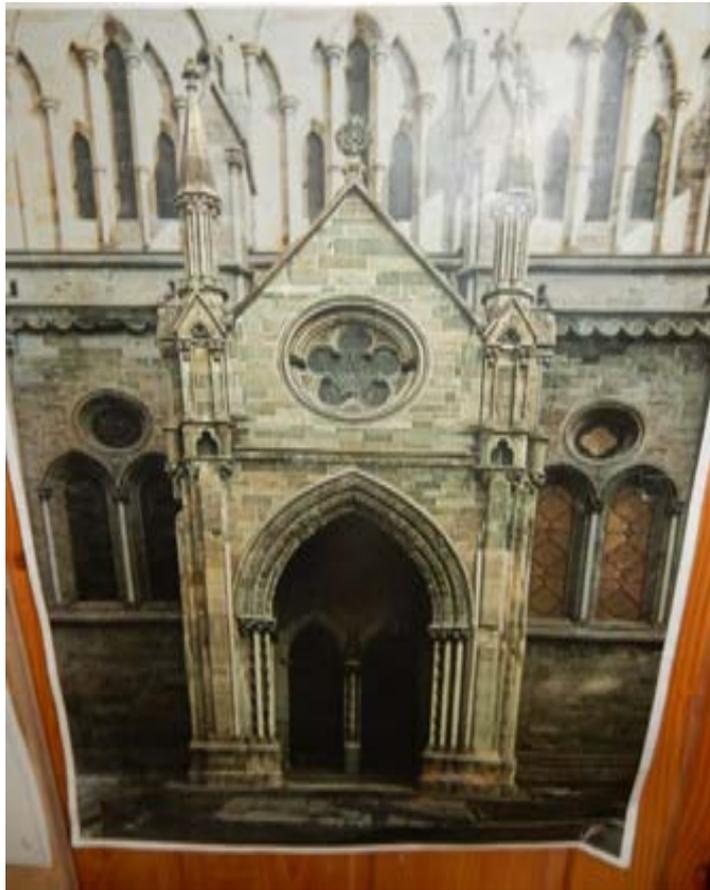
Figure 3: Photo of the King's Entrance before restoration

The King's Entrance is a portal with a porch on the south façade of Nidaros Cathedral's chancel. According to current history, it was built around 1230 and is today regarded as amongst the most decorative parts of the cathedral. Drawings from the early 1800s show the southern side of the chancel and the King's Entrance before the restoration of the cathedral that began in 1869.

cement mortar to 'glue' stones together has resulted in less façade stone and more infill, and the use of smaller stones and more infill has created a structure with poor bonding. Consequently, with its inflexible cement mortar and 'glued', the King's Entrance is rigid and subject to tensile forces (blowing stones apart).

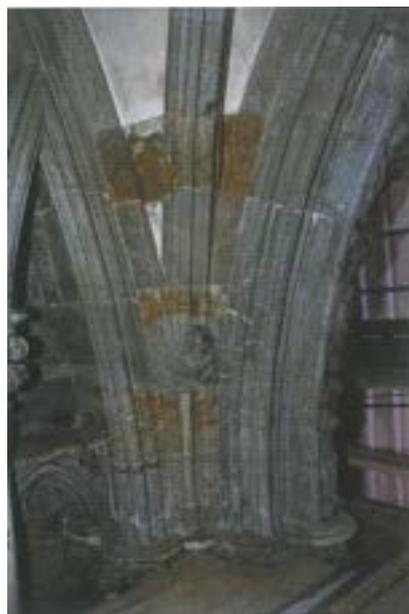
By the end of the first few days, I gained an appreciation of the development of the cathedral, its enormous history and the materials employed in its construction. The illustration below shows the deterioration of the soapstone in situ.

Figure 11: Deterioration of the soapstone in situ

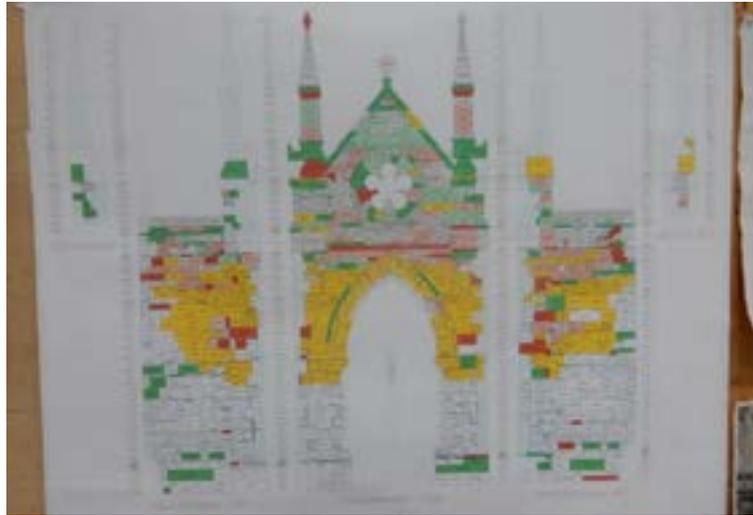
Figure 12: Marked elevation drawings

I poured over the marked up elevation drawings to gain a sense of the extent of the restoration process in terms of replacement stone and areas of masonry to be repaired.

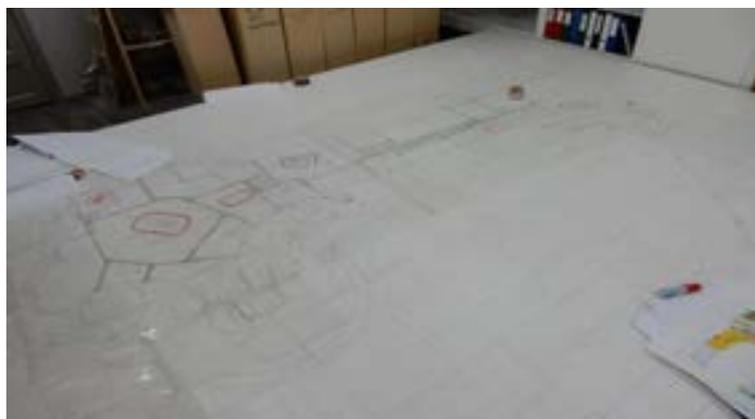
Figure 13: The tracing floor with full scale drawings

Each stone is given a unique reference number denoting its position in the wall. The full scale tracings are then passed onto the Stone carving Workshops to produce templates which allow the masons to replicate the exact dimensions of the replacement stones.

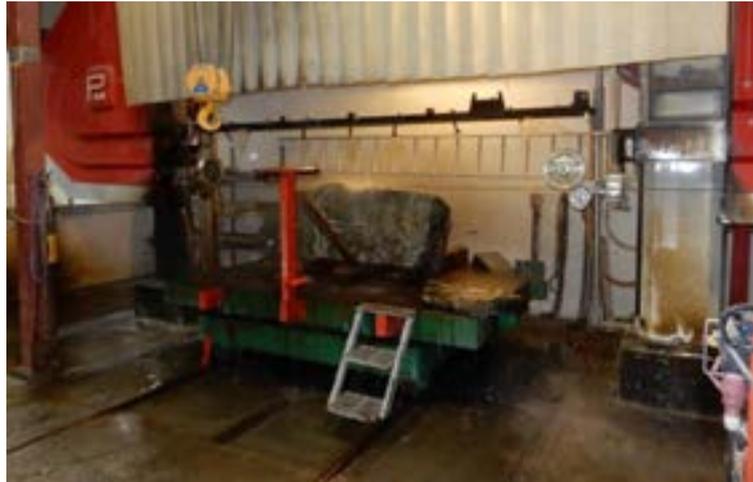
Figure 14: The stone carving workshop

The masons cut their own stone, first using wet saws with tungsten rope to generate the dimensions of stone to be carved.

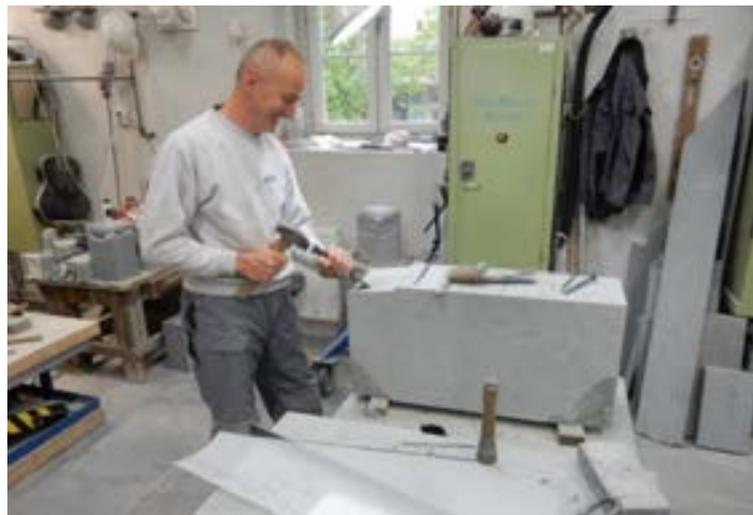
Figure 15: Roughing out of the stone

The mason here is 'roughing out' individual stones to fit to the templates.

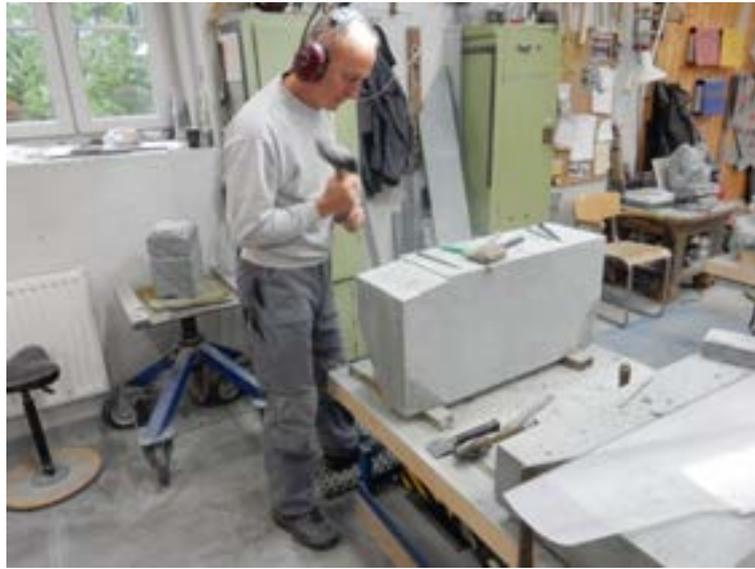
Figure 16: Trimming off waste with axe

The mason uses an axe to trim off waste ready for finishing chisels.

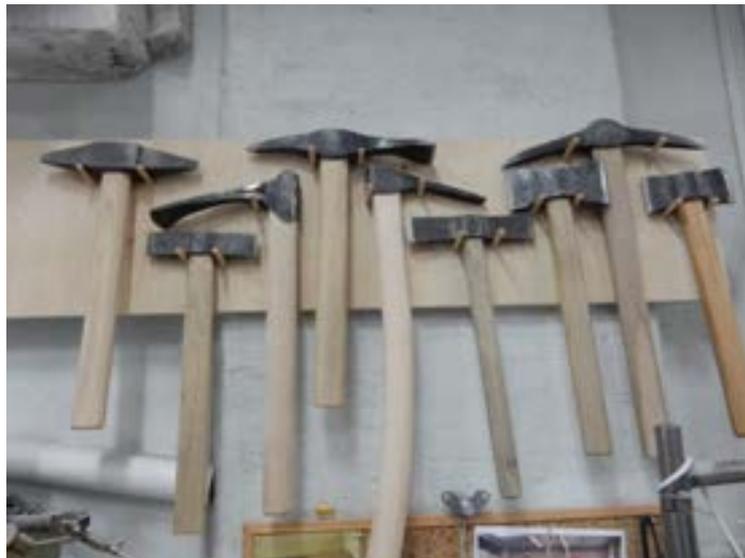
Figure 17: Selection of [mason's tools](#)

Above, a selection of the different axes used by the mason's. This is unlike tools used in Scotland for cutting and dressing sandstone (in the main).

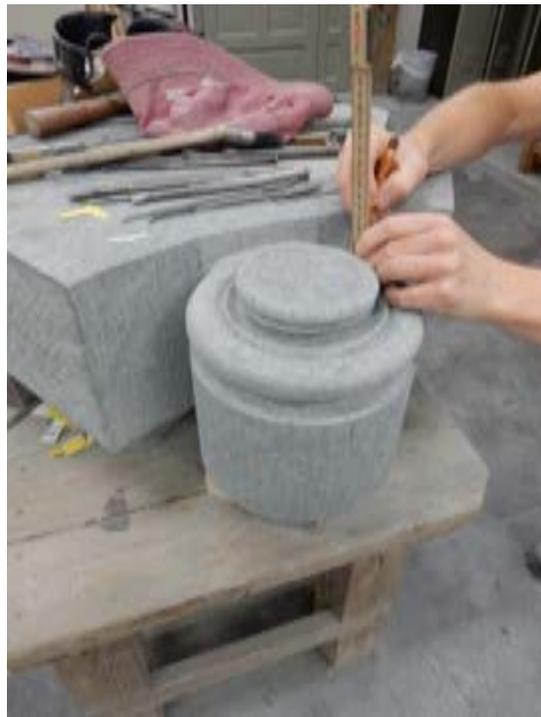
Figure 19: Last stone worked on during the course

The last stone being carved for the course of masonry I was working on.

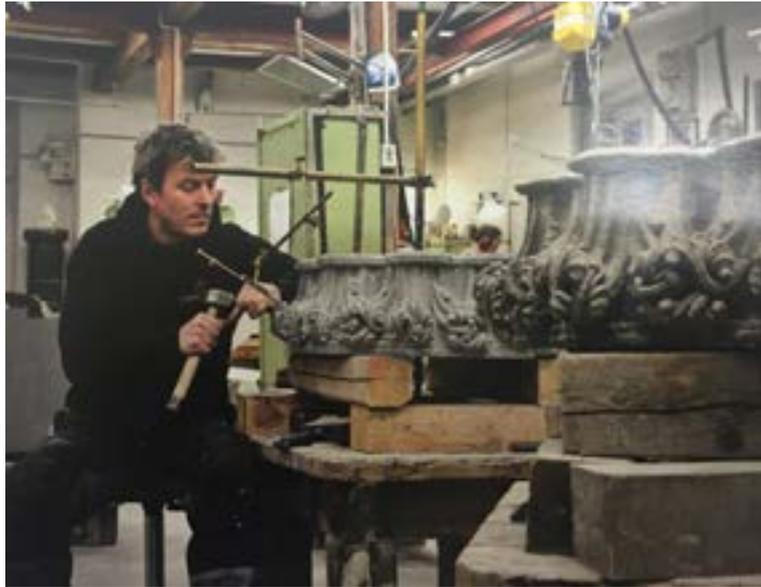
Figure 20: Capital carved with special guiding 'rig'

A new capital being carved with the aid of a special 'rig,' guiding and linking the dimensions of the old capital (in the foreground) to the new capital. A Medieval 3D printer!

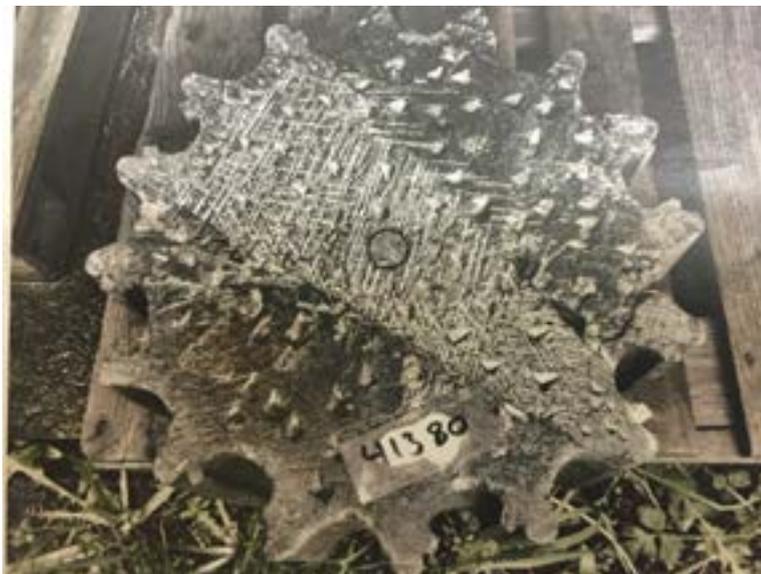
Figure 21: Repaired stone with dovetail joints

This stone has been repaired using dovetail joints to secure the new piece of stone (in the centre).

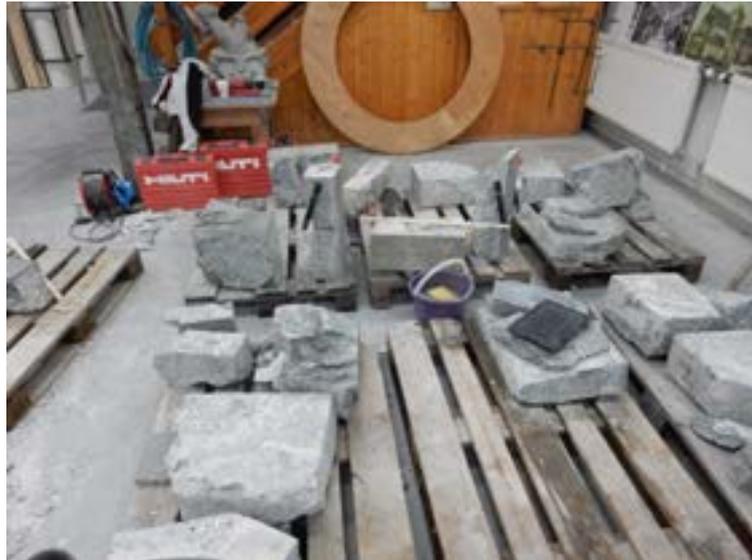
Figure 22: Pallet containing individual stones

Each numbered pallet of stone contains individual stones (with a unique reference number) to be assessed for full re-carving, partial indent (as above) or resin repair.

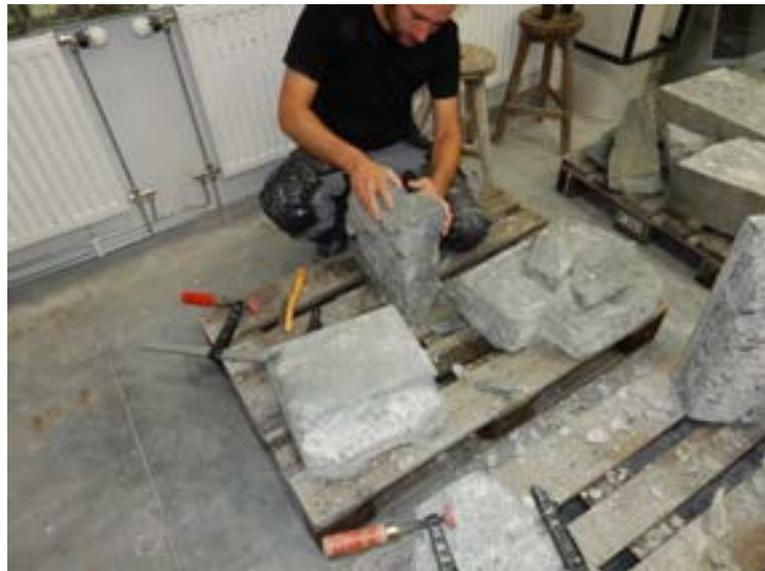
The mason is cleaning up the weathered stone, and 'dry' piecing it back together.

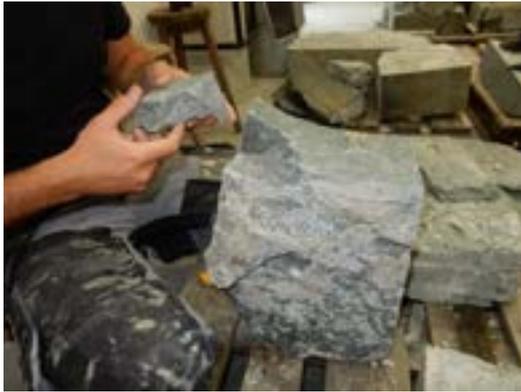
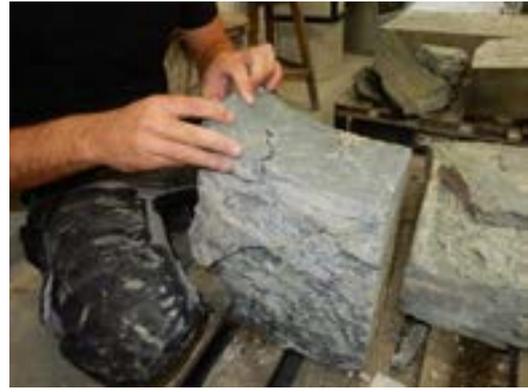
Figure 24-23: Mason piecing together stone

Once the 'jigsaw' has been put back together dry, then a resin glue is used to secure the repair (see below). This type of repair is only ever carried out on stones that will be in compression in the wall (ie with stones built on top of them rather than free standing elements).

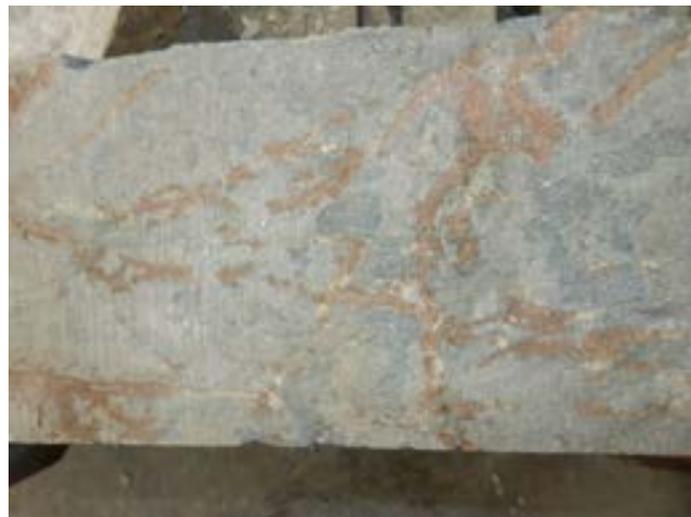
Figure 25: Stone showing the glue used to secure repair

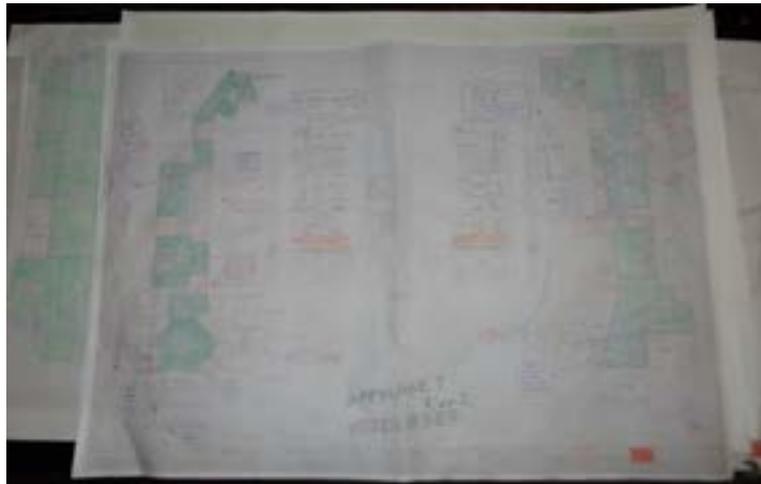
Figure 26: Drawing to identify stones

Guided by the drawings, we are able to identify all the stones required for rebuilding the course of masonry in hand. As all the stones have individual numbers, it is relatively easy to locate them, unless individual errors have been made. Then it is like finding a needle in a hay stack!

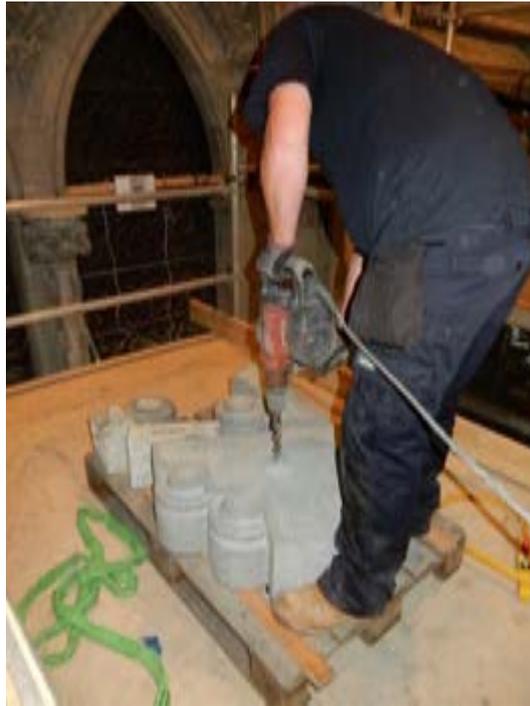
Figure 28: Preparations for the Lewis Pins

Preparing the stones to be lifted individually using the traditional way by Lewis Pins. These are like back to front 'scissors', the pins being anchored into drilled holes in the stones.

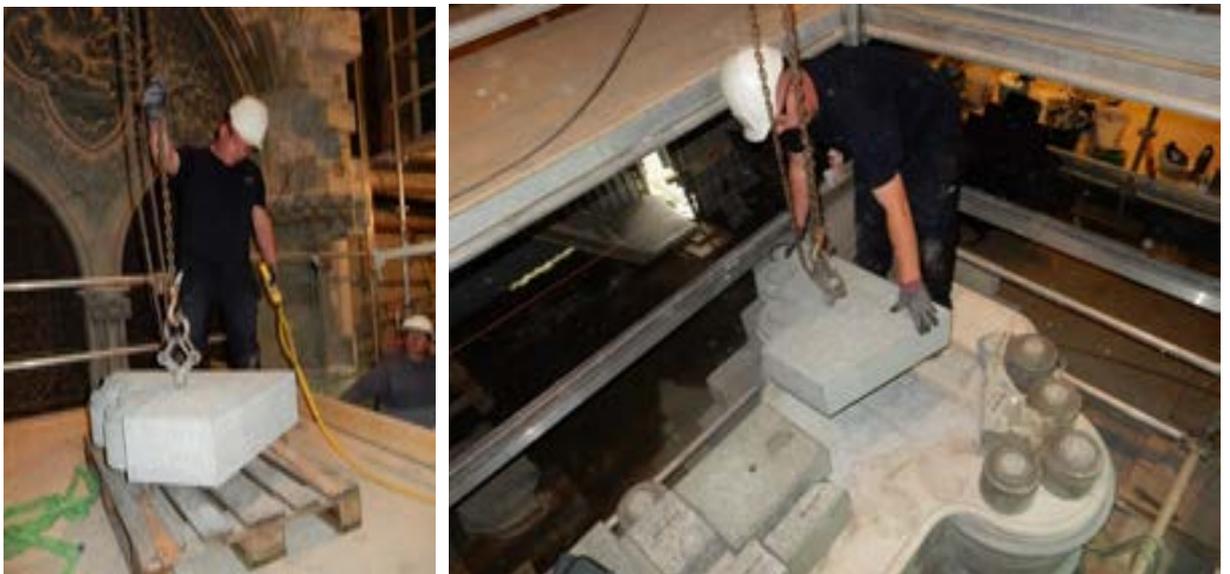
Figure 29-29: Lifting of stones with Lewis Pins and 'dry' laying stones to check position and dimension

'Dry' laying the stones in place to check for position and dimension checking.

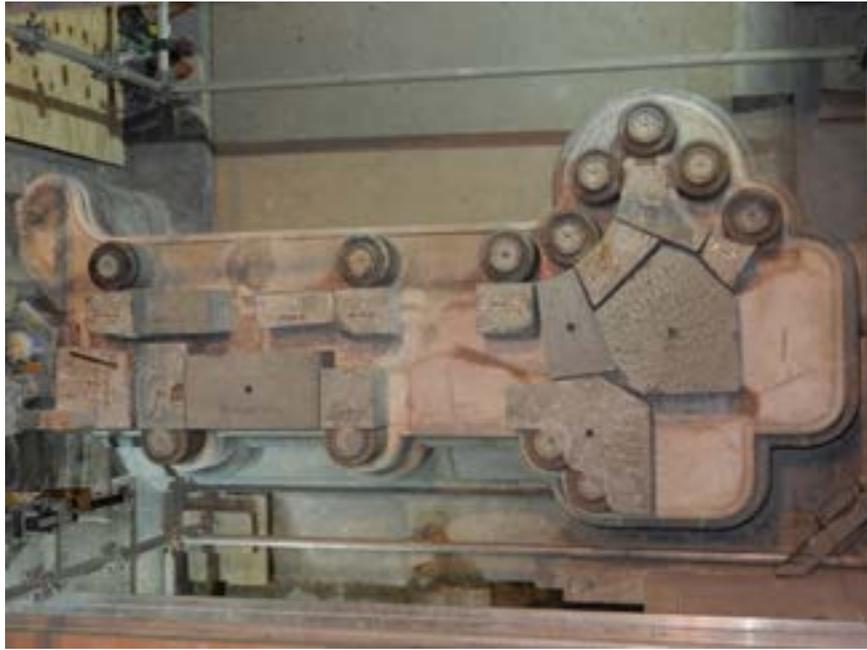
Figure 31: Finished 'dry' laying showing the position of the different stones

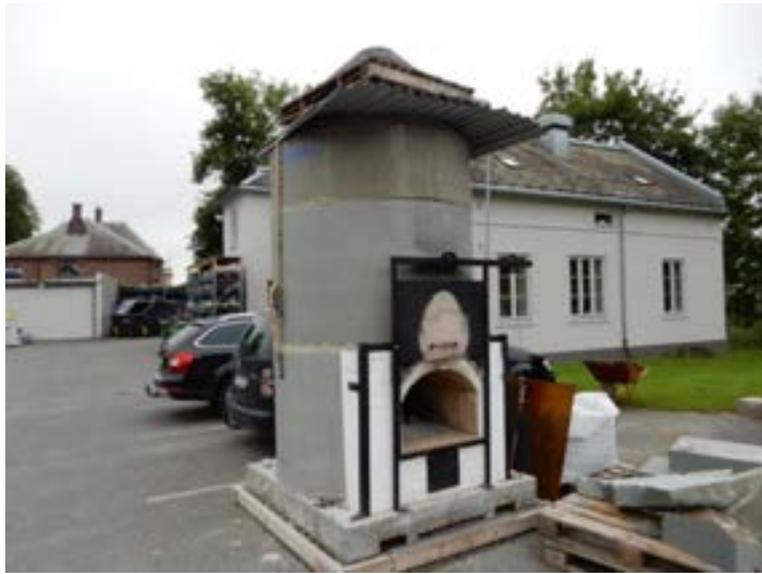
Figure 32: Kiln used to burn the quicklime

In a determined attempt to be authentic, both technically and aesthetically, the decision was made to burn local limestone to make the mortars. Quicklime (the product made in a limekiln (above) is then mixed with a local sand and water under controlled conditions). There is an exothermic reaction when quicklime is exposed to water and this can produce high temperatures within a very few seconds. Essentially a caustic soup has been made that can have serious consequences if in contact with exposed skin or eyes. Health and safety at the cathedral is taken very seriously, and echoes practices we adopt at the SLCT.

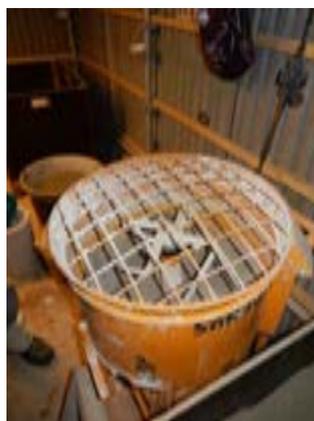
Figure 33: Forced action mixer

A forced action mixer is used to produce the mortar.

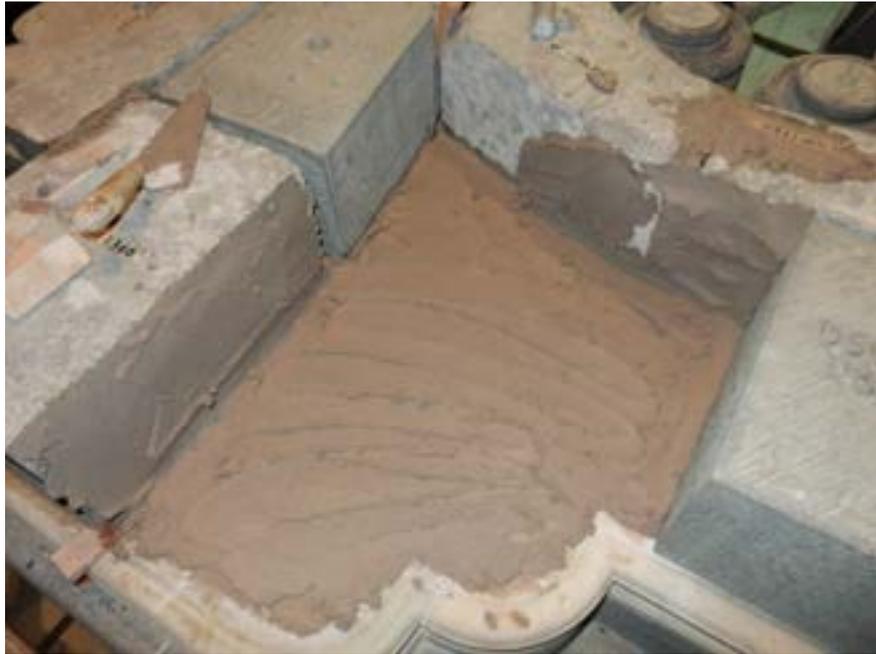
Figure 34: The mortar bed for the stone

A bed of mortar is laid down to receive the replacement stone. It is important to make sure the perpendicular joints (vertical) are fully coated with mortar.

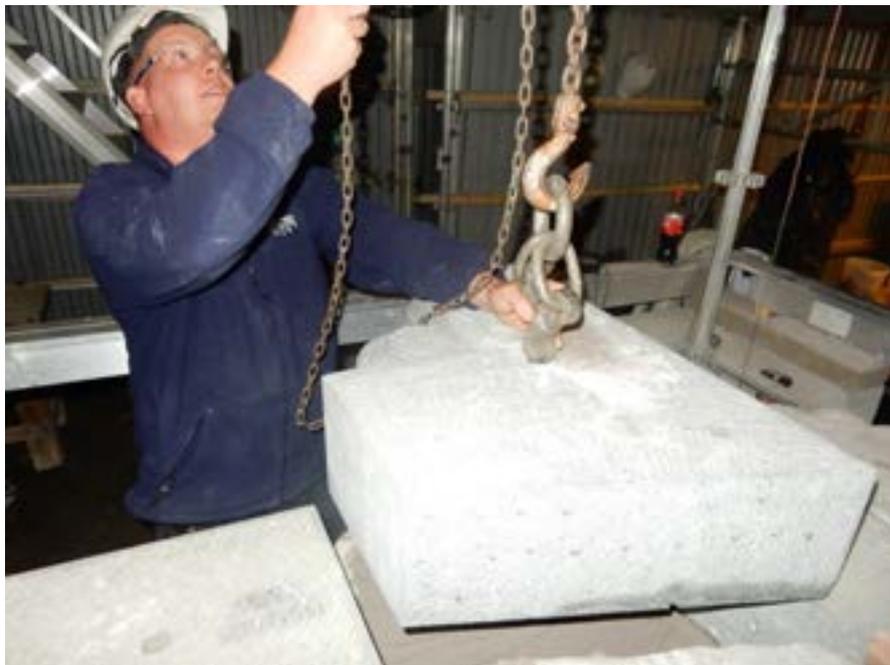
Figure 35: Lowering the stone onto the mortar bed

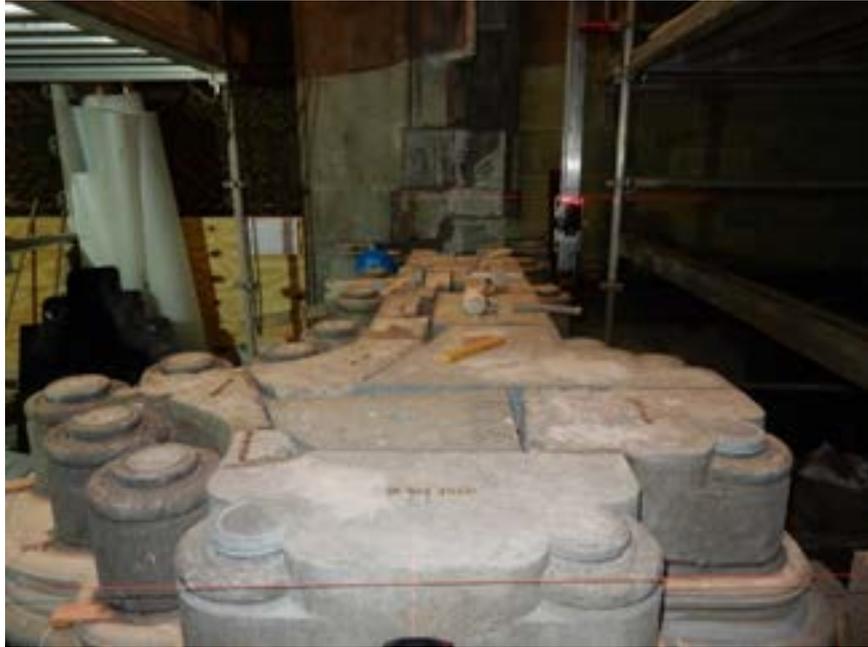
Laser check to ensure everything is plumb and level.

Figure 36: Lines and laser check to ensure it is plumb and level

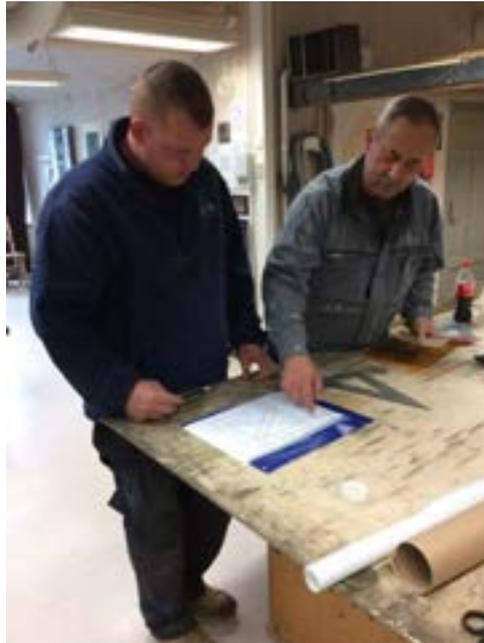
Figure 37: Design for the glass work

As an extra bonus, I was introduced to two new trades, the first being stained glass. I was given guidance on how to design and cut out pieces of glass to form a Saltire Cross.

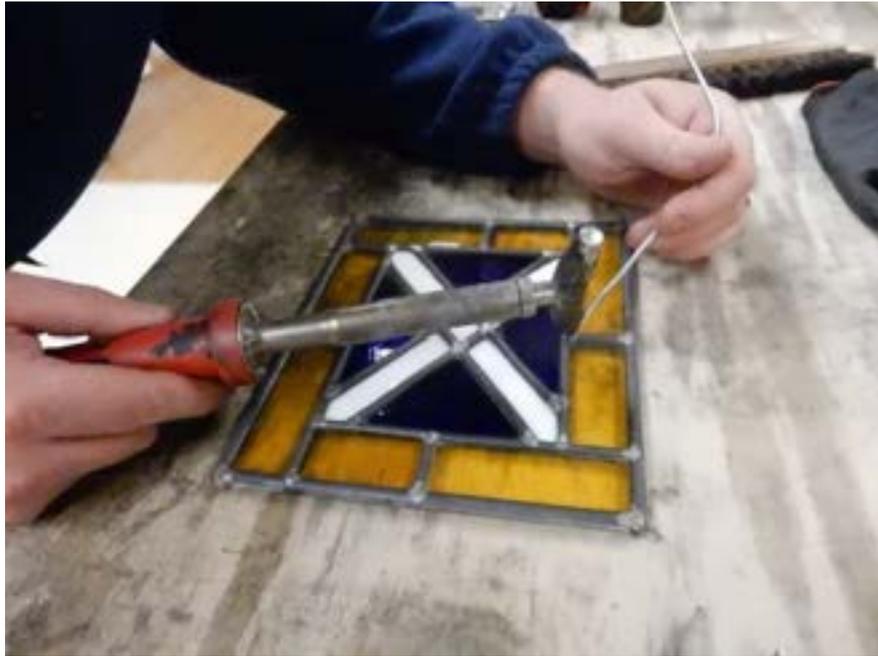
Figure 40: Soldering the glass together

Soldering the lead comes.

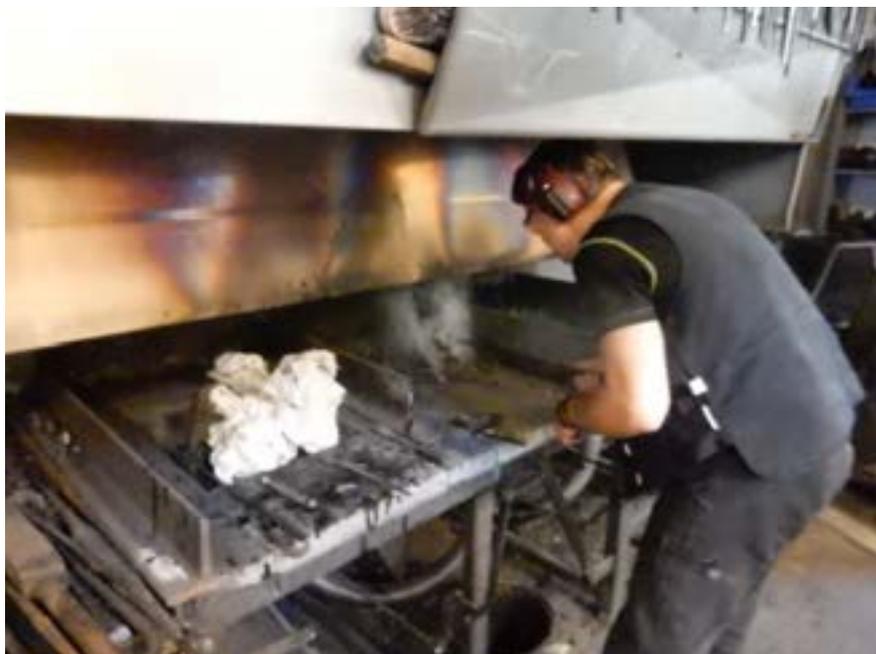
Figure 43: Furnace while fire is being lit

Lighting the fire to get the furnace going.

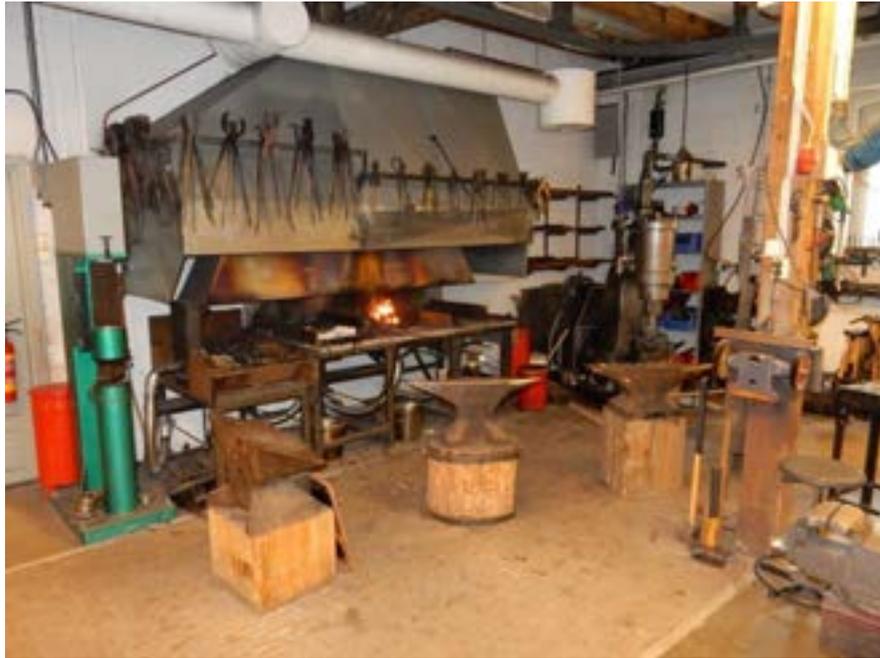
Figure 44: Lit furnace and blacksmithing workshop

With the furnace going, work could start on creating a metal scribe (for marking stonework).

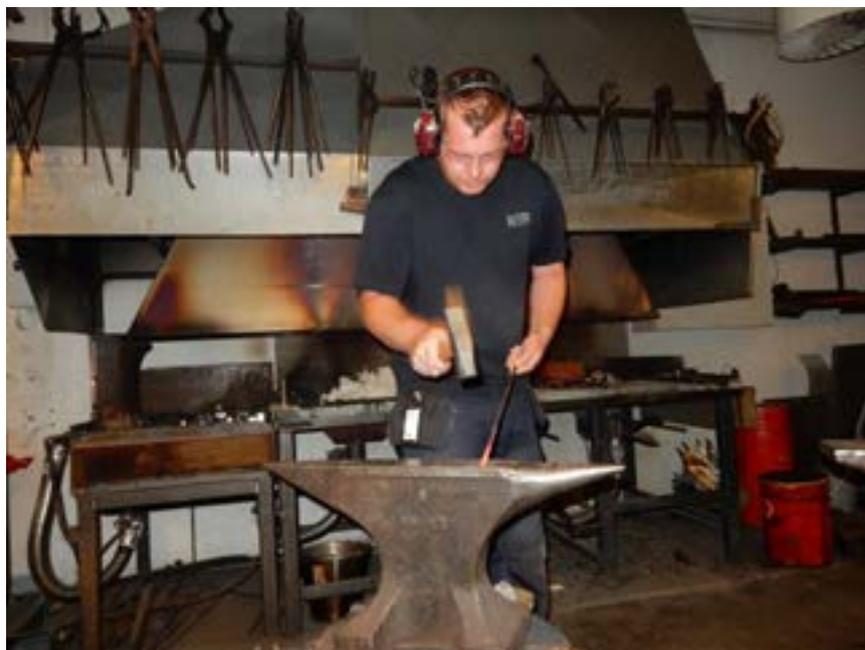
Figure 45: Hammering metal

Hammering hot metal to stretch it into the desired shape.

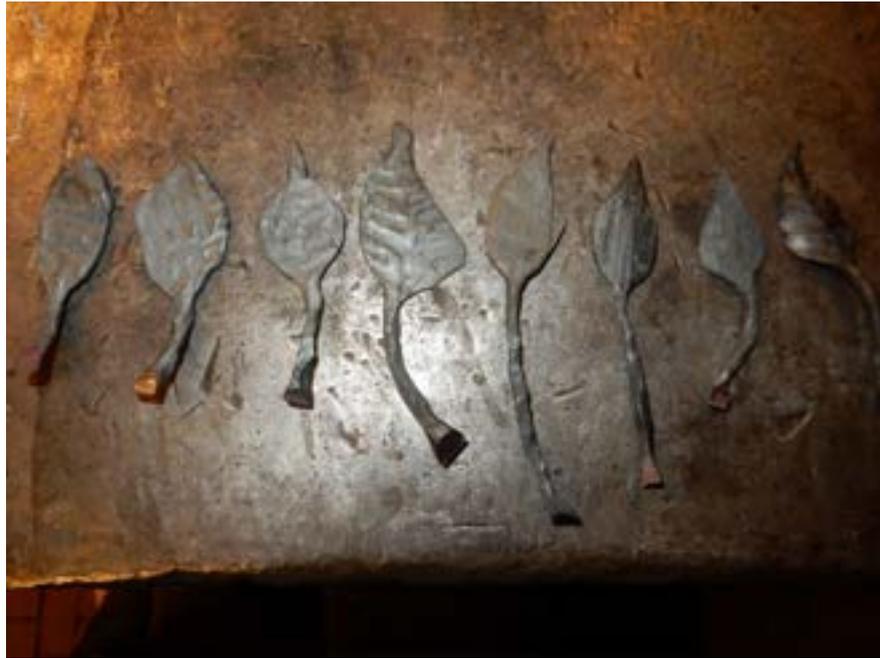
Figure 46: Metal leaves

Practice pieces to create a leaf shape.

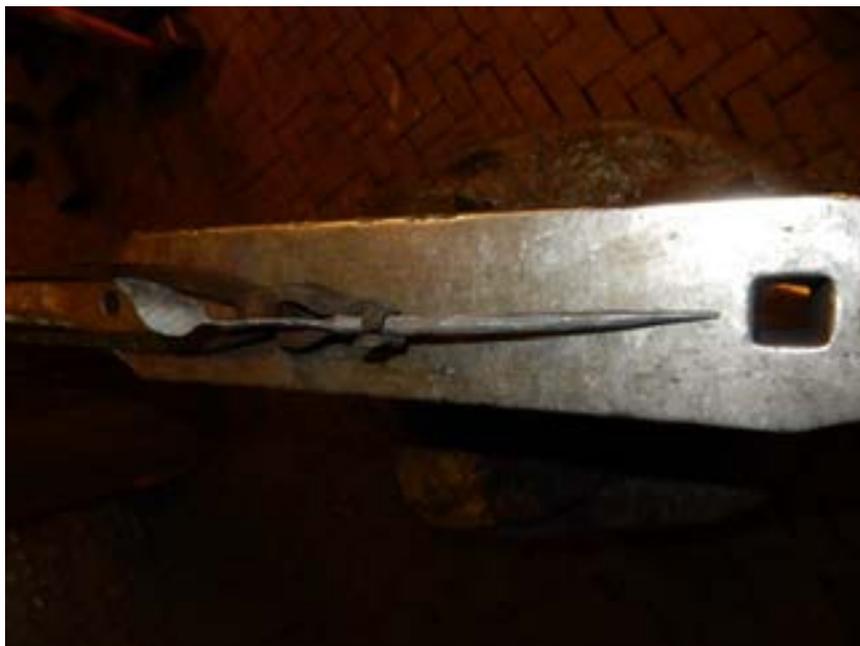
Figure 47: Almost finished scribe

Almost finished scribe ready to be bend into shape.

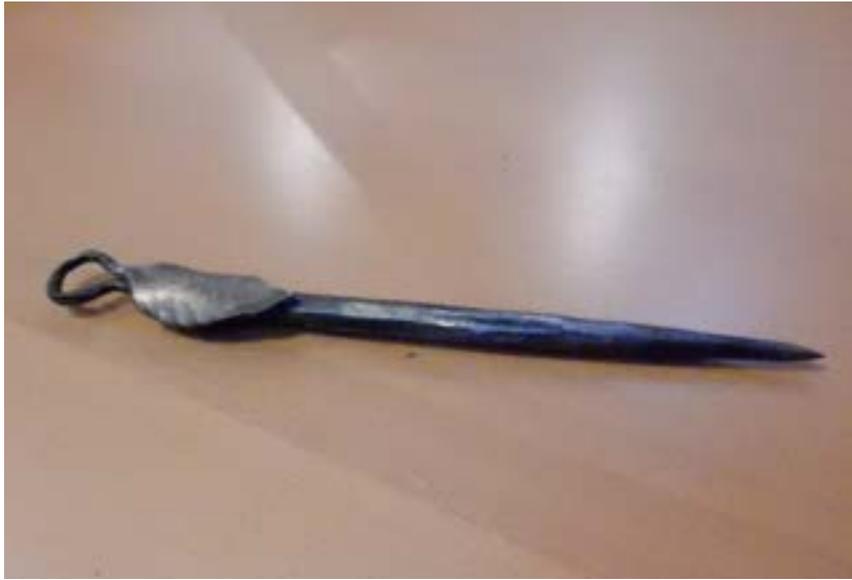
Figure 48: Finished scribe to mark stones for masonry process
